**An Architectural Analysis and Earthen Finish  
Characterization of Cavate M-100, Frijoles  
Canyon, Bandelier National Monument,  
Los Alamos, NM**

Kathleen Anne Forrest

A THESIS

2001

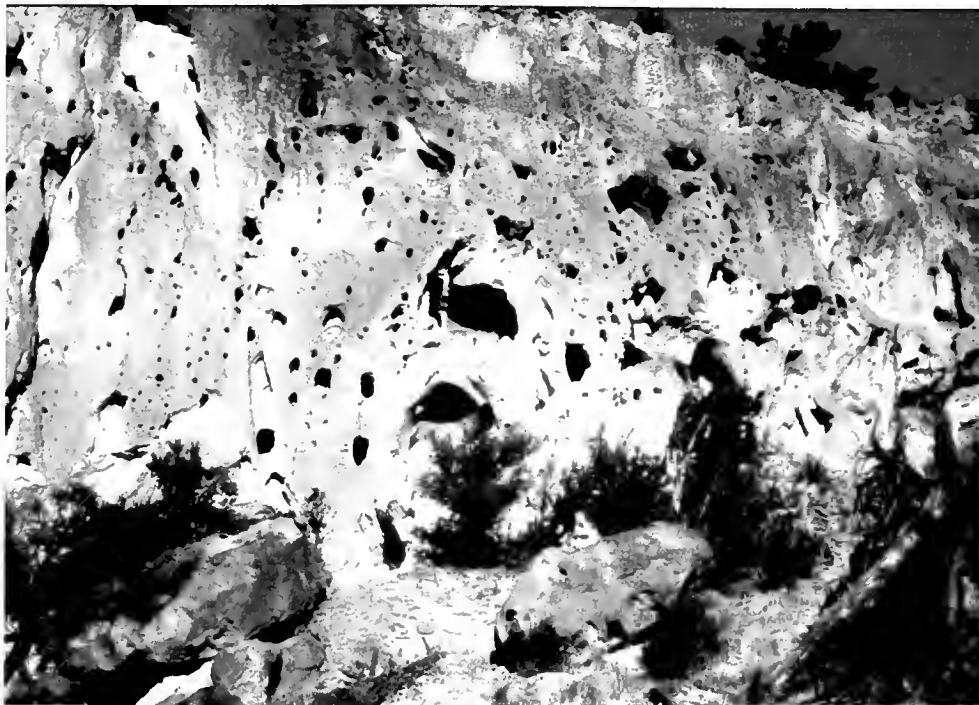
Figure 1. Cavates in Frijoles Canyon, Bandelier National Monument. Photograph courtesy Frank G. Matero.

In North America, cavate structures represent a small but unique type of indigenous architecture in the southwestern United States, especially in northern New Mexico and Arizona. Cavates have been defined as “cavities in the canyon wall that are primarily the result of excavation of the rock.”<sup>1</sup> Unlike most of the archaeological record, cavates are easily documented without excavation. They are similar to dry caves, although they are human-made, and as such they preserve many fragile features that otherwise would be destroyed. These features include earthen architectural finishes and organic materials, as well as full walls and intact ceilings, all preserved remarkably well.<sup>2</sup> (*See Figure 1*)

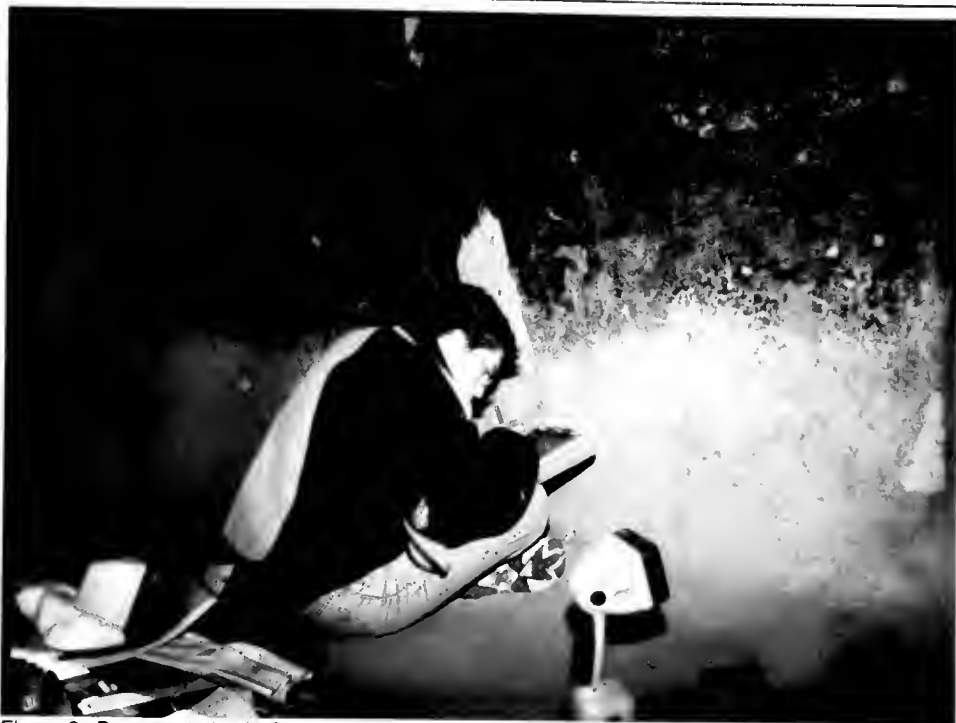
Figure 6. Documentation in Cavate M-100, Frijoles Canyon, Bandelier National Monument. Photograph courtesy Frank G. Matero.

The first step of survey was to prepare a condition assessment form for the space. The objectives of this survey were to identify and describe the existing architectural fabric; to record the condition of the cavate and its features as a baseline for monitoring and planning future conservation work; to identify threats to the current condition and integrity of the resource; to determine treatment urgency and recommend treatments; and to provide information needed to prepare a long-term preservation and management plan for the cavates.<sup>38</sup> (See Figure 6)

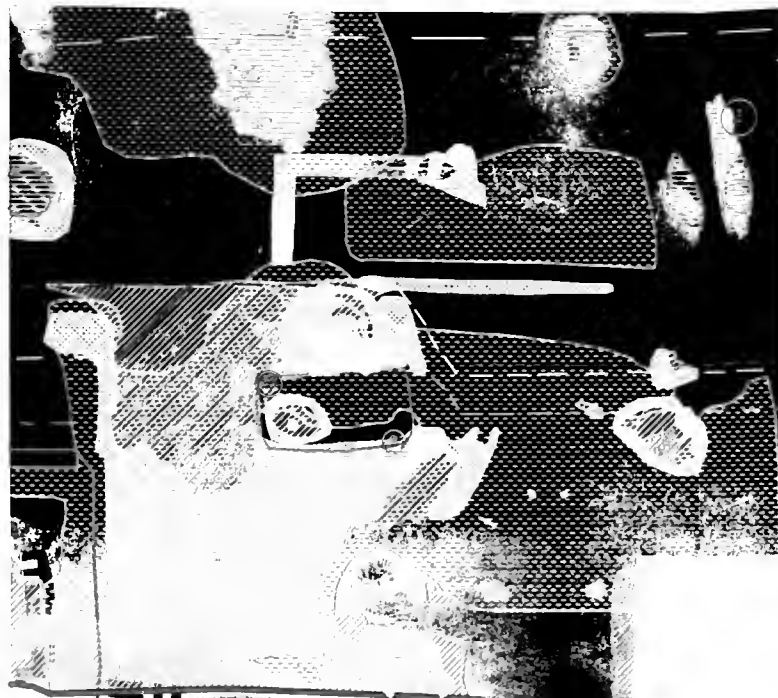
CAVATE M-100, GROUP M, FRIJOLE CANYON  
BANDELLER NATIONAL MONUMENT

Notes: Total loss, partial loss, detachment and delamination.

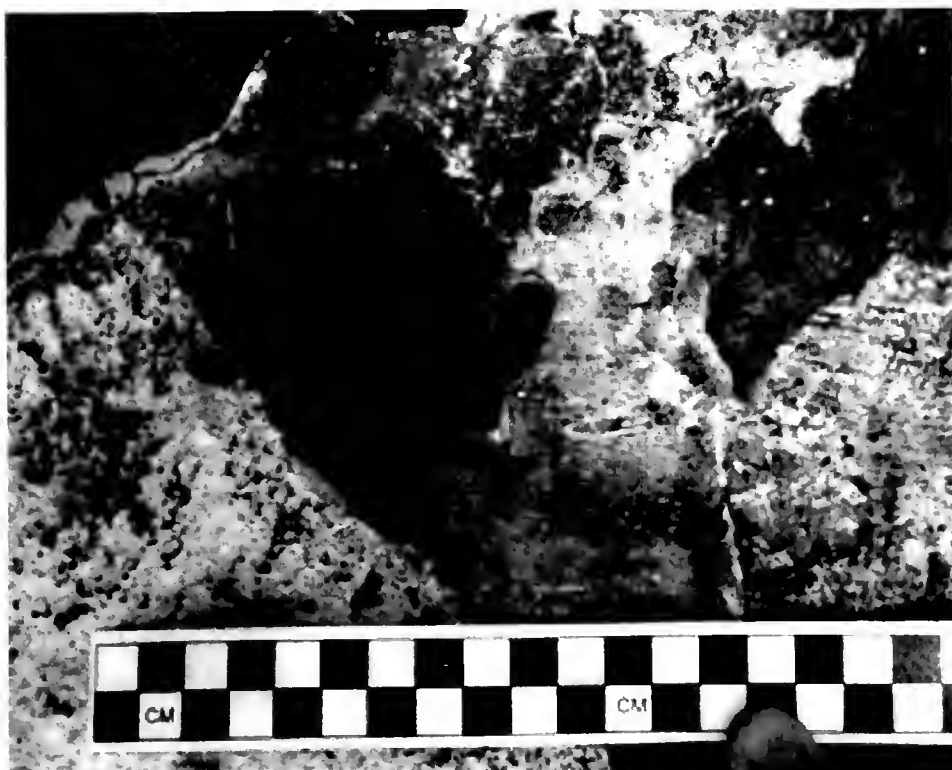
Figure C.9 Matthew J. Liebmann, June 24, 2000 Detail, Sector 8, Panel E.  
Photograph courtesy of Matthew J. Liebmann.

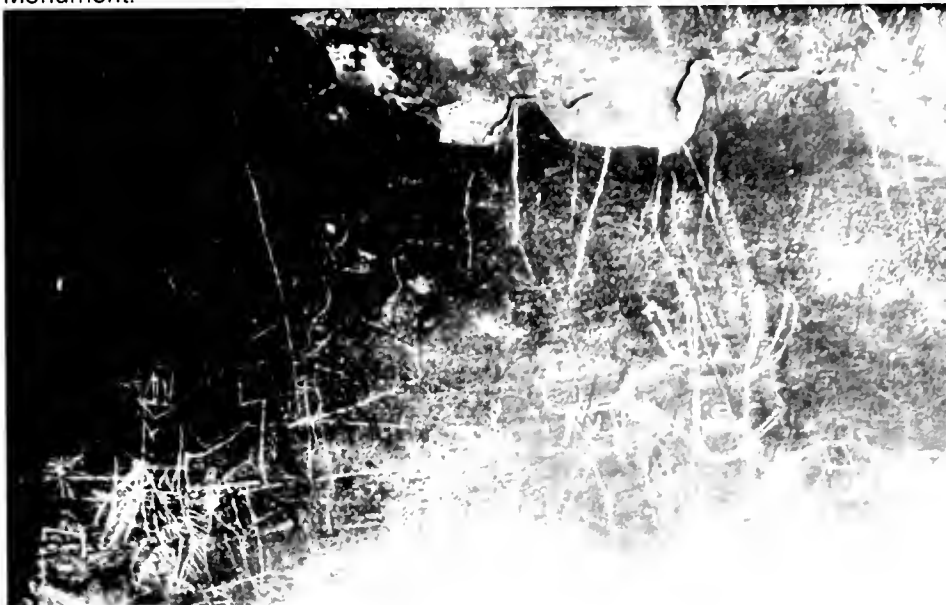
Figure C.14 Charles Steen, April 1943. East Wall, Sector 12, Panel P. Bandelier Negative Number 00198A. Photograph courtesy of Bandelier National Monument.

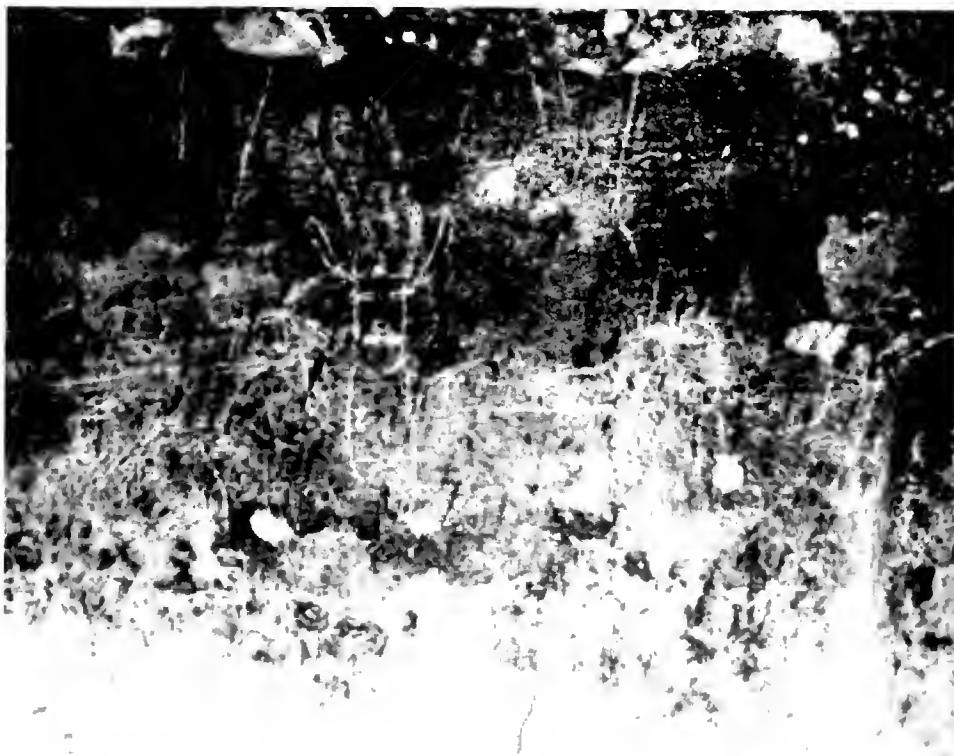
Figure C.21 Matthew J. Liebmann, June 24, 2000. Detail, Sector 14, Panel P.  
Photograph courtesy of Matthew J. Liebmann.

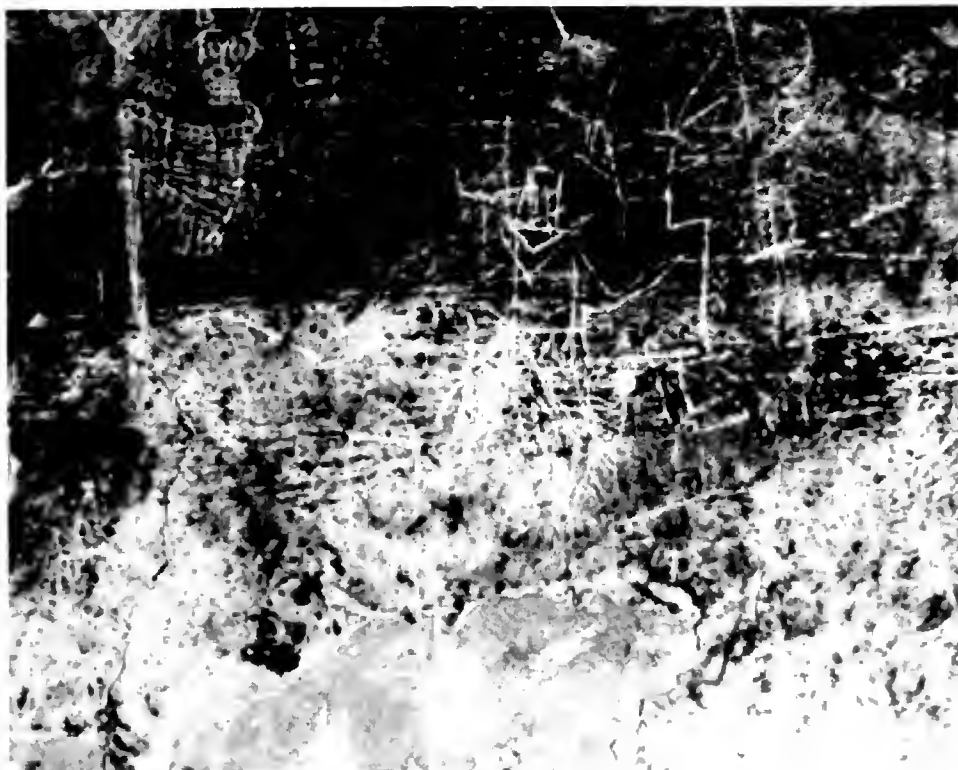
Figure C.22 Matthew J. Liebmann, June 24, 2000 Detail, Sector 12, Panel N  
Photograph courtesy of Matthew J. Liebmann.

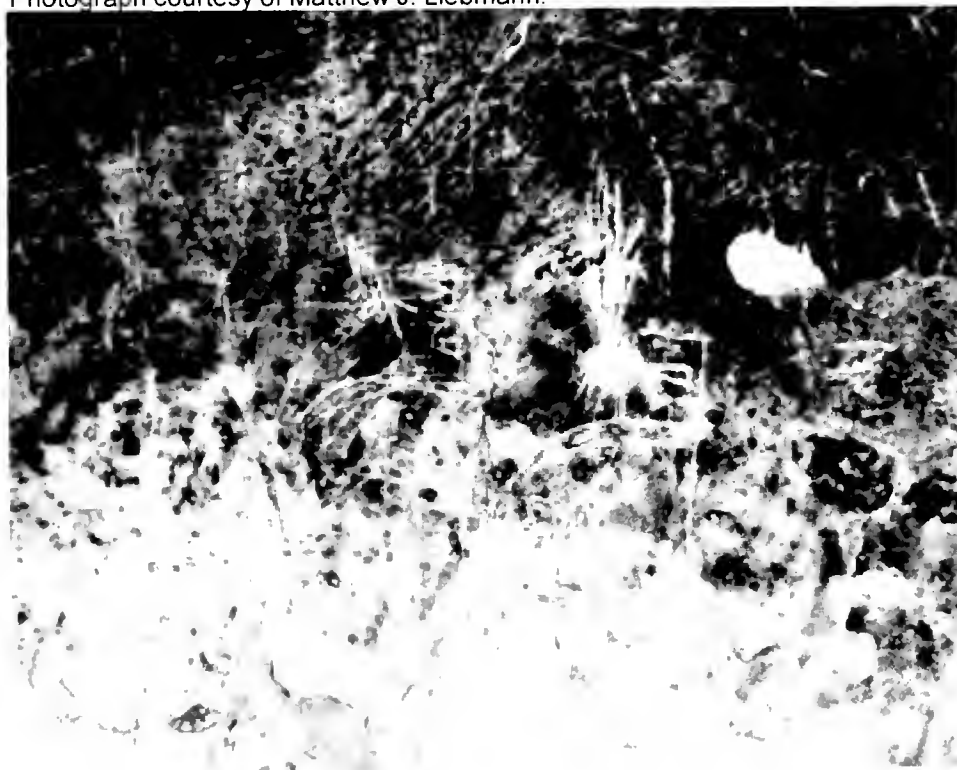
Figure C.23 Matthew J. Liebmann, June 24, 2000 Detail, Sector 12, Panel O.  
Photograph courtesy of Matthew J. Liebmann.

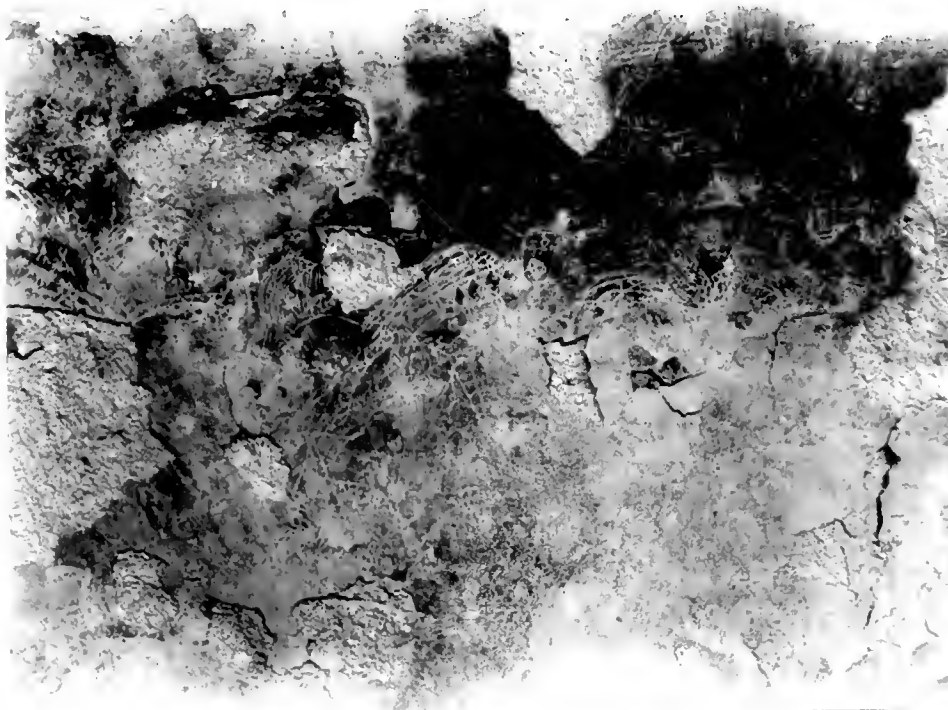
Figure C.27

Charles Steen, April 1943. Location Unknown. This photograph is attributed to M-100, however this may be inaccurate. There is no evidence in M-100 of this embellishment. Bandelier Negative Number 00199A. Photograph courtesy Bandelier National Monument.

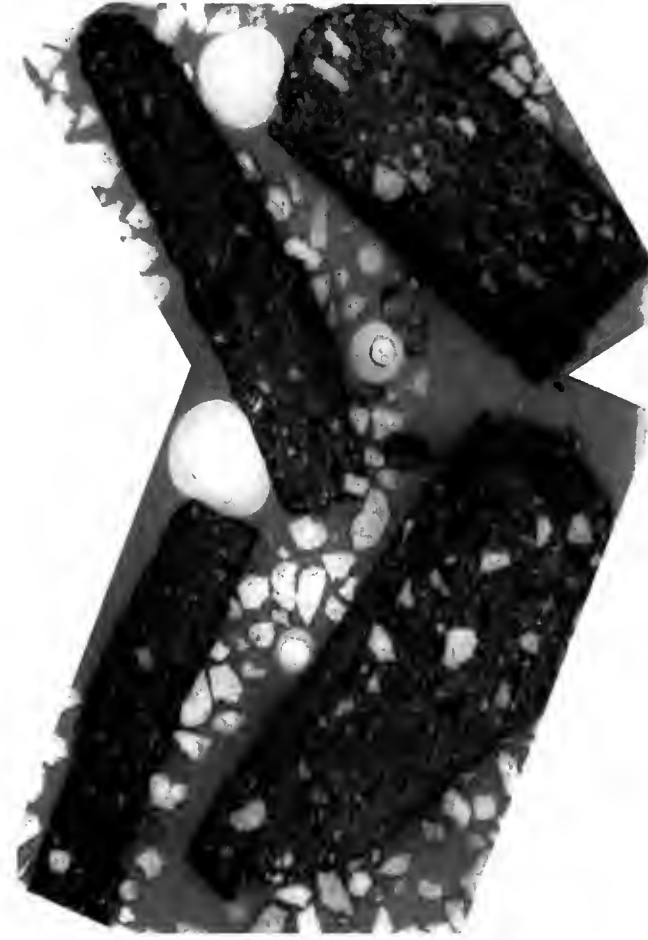
## Sample BAND M-100.02

East Wall,  
North Half  
1.60 m from floor  
.29 m from  
north wall  
125

There are large inclusions in layers 2, 4, 6, 8, 10, 18,  
and 20.

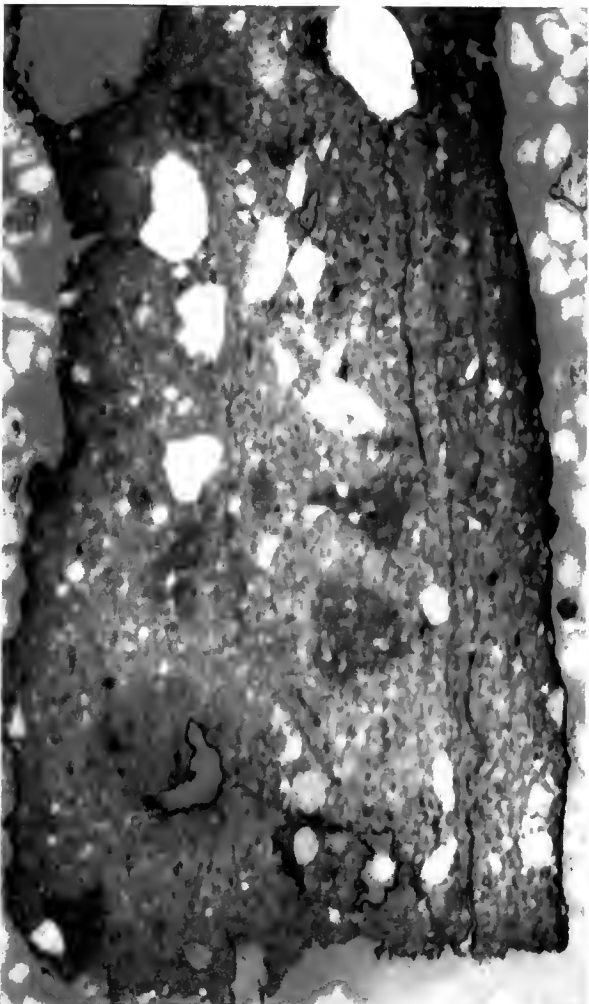
**Sample BAND M-100.06**

West Wall,  
North Half  
.78 m from floor  
.41 m from  
west wall  
134

There are large inclusions present  
in layers 2, 4, 10, 12, and 14.

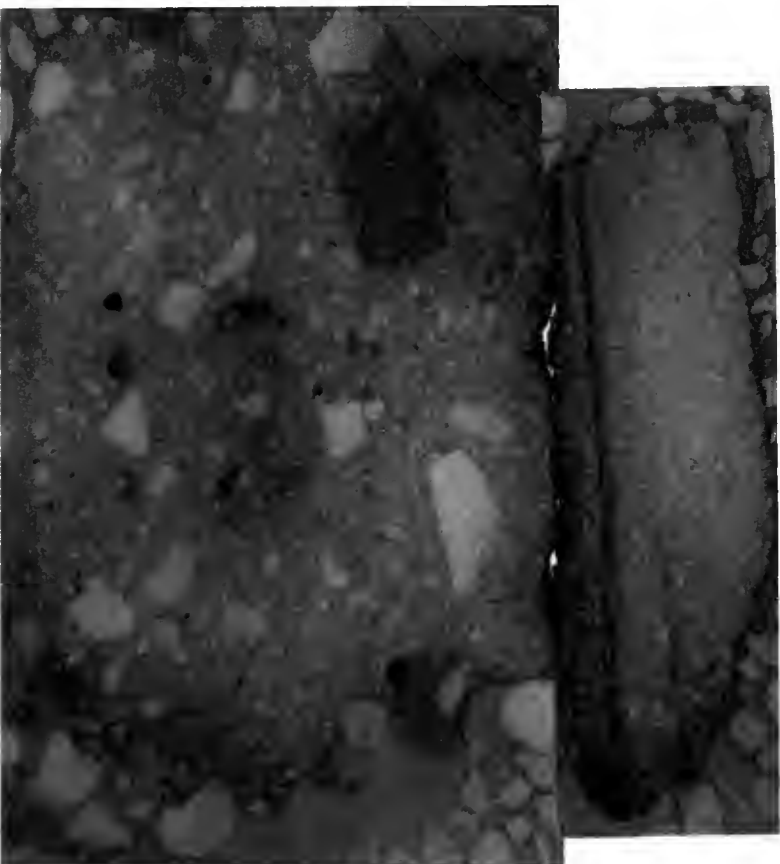
**Sample BAND M-100.09**

Large inclusions present in layer  
9. This sample was broken, and  
has been digitally reconstructed.

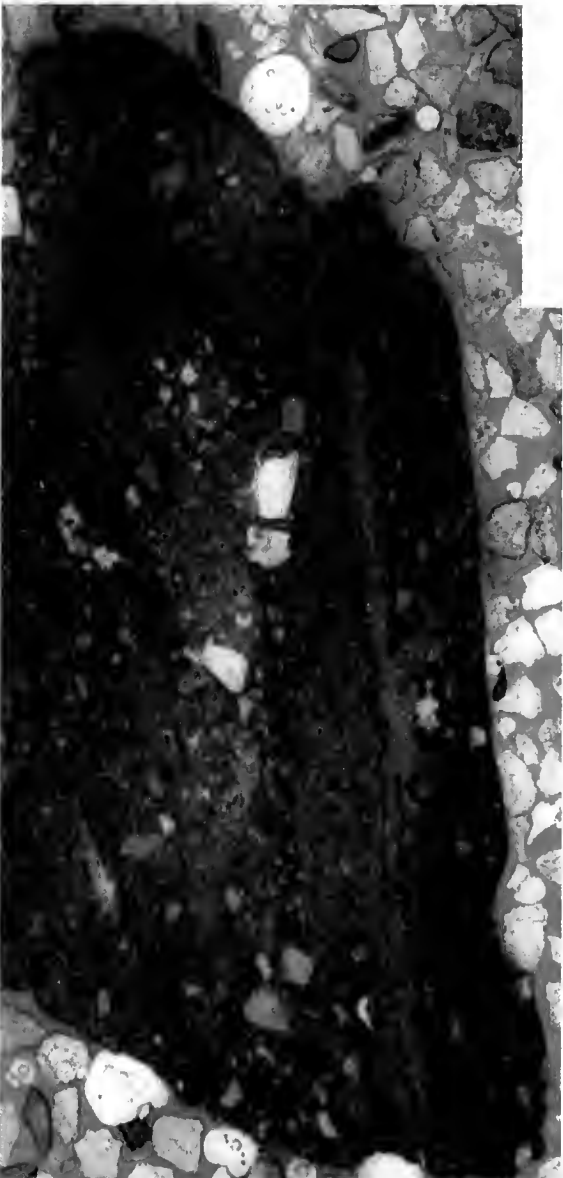
Sample BAND M-100.15

There are large  
inclusions present in  
layers 1, 2, 3, 13, 15,  
and 17.

Lower North Wall,  
East Half  
Floor Sample  
17 cm from  
East Wall  
149

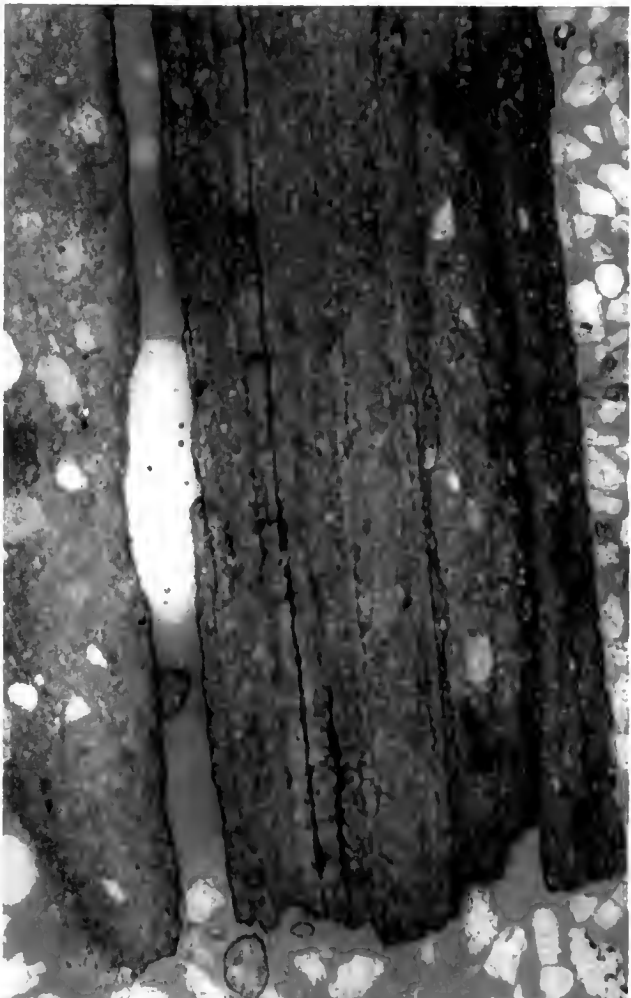
## Sample M-100.19

There are large inclusions present  
in layers 4, 12, 16, and 40.

Lower West Wall,  
South Half  
30 cm from floor,  
1.46 m from door  
153
